Evaluation Report

402

PRAIRIE AGRICULTURAL MACHINERY INSTITUTE

SPERRY NEW HOLLAND 1100 SELF-PROPELLED WINDROWER

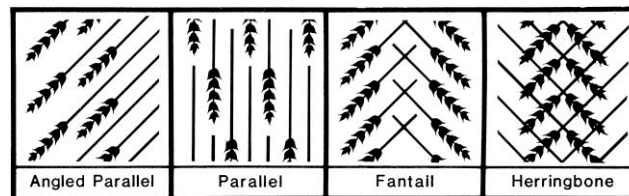
FIGURE 6. Windrow Types.

Windrow Formation: Windrows may be classified into four general patterns (FIGURE 6), although many combinations and variations exist. Windrow formation was very good. FIGURES 7 to 11 show typical windrows formed by the NH 1100. Centre delivery windrows were usually formed parallel or fantailed. Alternating end delivery resulted in parallel or angled parallel windrows depending on direction of crop lean. Herringbone windrows occurred in light crops, while fantailed windrows occurred in heavy tall stands or ripe crops. Hay windrows were wide and parallel which could make them difficult to pick up. The 1116-D draper header was not recommended for use in hay.
